# 100 years of Accumulated Deformation at Depth Observed in the Elizabeth Lake Tunnel, Southern San Andreas Fault

A. Tayyebi<sup>1</sup>, J. Telling<sup>1</sup>, K. Hudnut<sup>2</sup>, C. Davis<sup>3</sup>, C. Glennie<sup>1</sup>

# Elizabeth Tunnel, CA

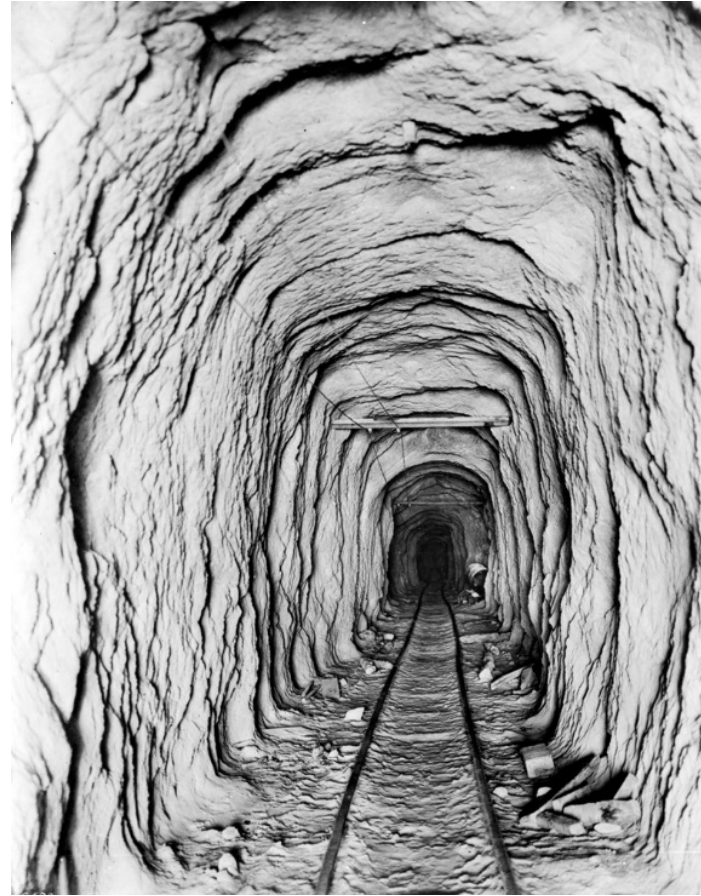
- o Terrestrial Laser Scanning
  - o Collected in 2012
  - o Nearly 200 TLS scans
  - o Cross section example on right
- o Research Questions
  - o Has the tunnel shifted since it's construction?
  - o What scale of change can be detected given the variability in the tunnel itself?
  - o Can the tunnel – fault intercept be isolated to a narrow region for re-engineering?

5 ft

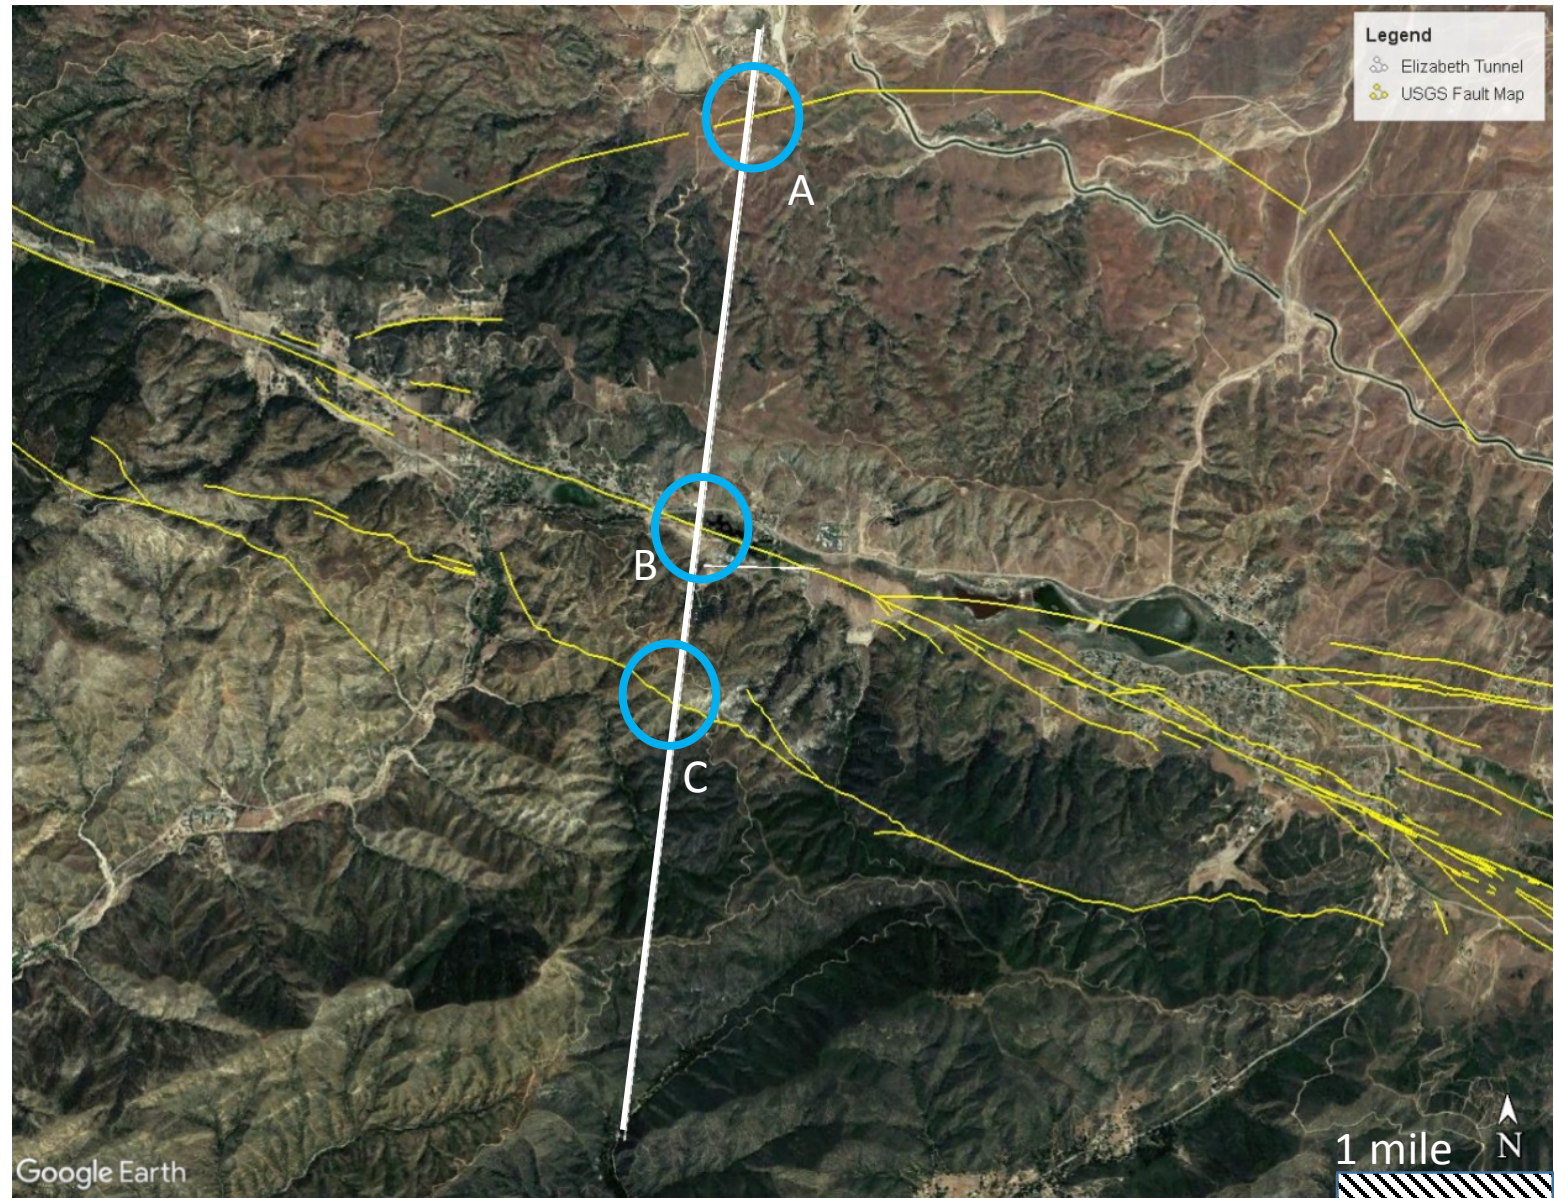
- Three known fault tunnel crossings (A, B, and C from North to South) (8)
- The center (B) strand was active in the 1857 earthquake
  - Slip rate ~15-35 mm/yr
  - Eberhart-Phillips et al. (1990) (7)
- Less work on slip rate and fault dip has been completed on the northern and southern strands (A and C)
